March 10th, 2015

Project Number 114490C

Subject: Laboratory Load Test of the QMHLS with 6061 Base Plate

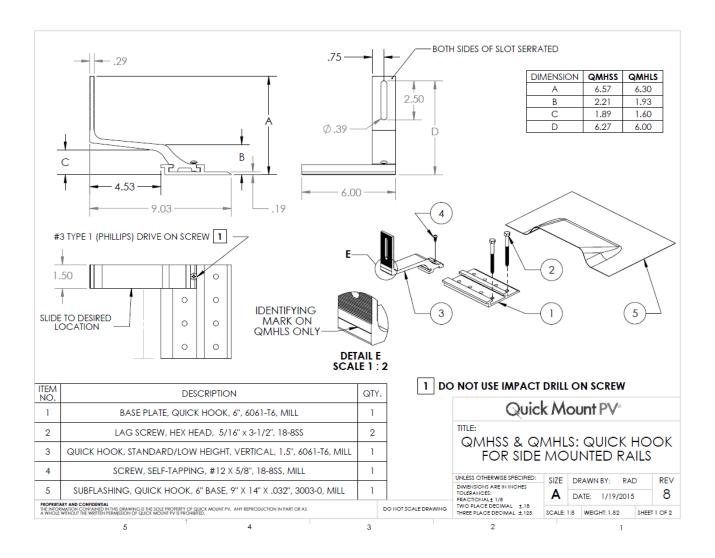
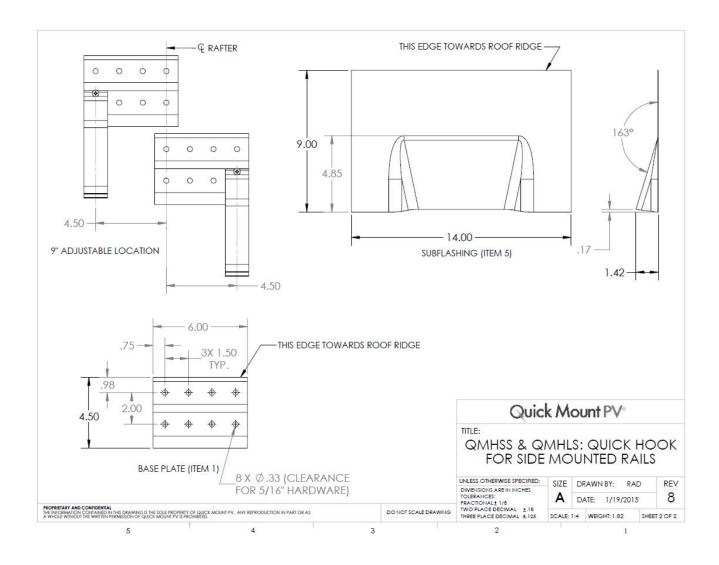
APPENDIX A

QMHLS- 6061 BASE PLATE

Samples were assembled in our laboratory between January 10th and January 15th, 2015. Mockup configuration consisted of three 16" long rafters at 4.5"o.c., screwed to 1/2" Structural I plywood. The QMHLS is attached through the plywood into a rafter with two 5/16" ø x 3.5" fasteners installed at the farthest point on the 6061 base plate. QMHLS and 6061 base plate configurations are provided in Appendix A.

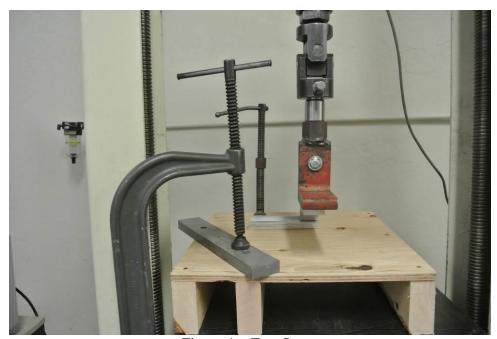
Figure 1a. Test Setup

COMPRESSIVE LOAD TEST SETUP

A total of six tests were conducted for compressive load capacity on January 14th, 2015 using a United Universal testing machine. Samples were rigidly attached to the testing machine and a compressive load was applied to the hook. The samples were loaded in compression at a constant rate of axial deformation of 0.09 in. /min. without shock until the hook was bent and came in contact with the test board; displacement at maximum load was recorded. Based on the above testing, the average maximum compression load of the QMHLS attached to a 2"x4" Douglas Fir rafter using two 5/16" ø x 3.5" lag bolts was determined to be 683 lbf. Detailed results are provided in Table I. Test setup and mode of failure are provided in Appendix B, Figure 1.

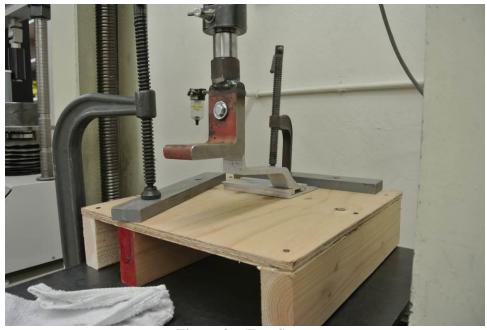
Figure 2a. Test Setup

TENSIL (UPLIFT) LOAD TEST SETUP

A total of six tests were conducted for tensile load capacity on January 15th, 2015 using a United Universal testing machine. Samples were rigidly attached to the testing machine and an uplift load was applied to the hook. The samples were loaded in tension at a constant rate of axial deformation of 0.09 in./min. without shock until failure occurred; displacement at maximum load was recorded. Based on the above testing, the average maximum tensile load of the QMHLS attached to a 2"x4" Douglas Fir rafter using two 5/16"Ø x 3.5" lag bolts was determined to be 1112 lbf. Detailed results are provided in Table II. Test setup and mode of failure are provided in Appendix B, Figure 2.

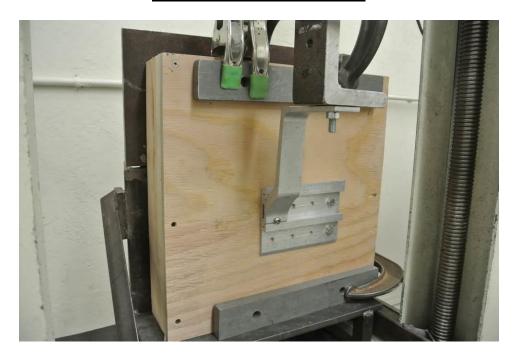
Figure 3a. Test Setup

SHEAR (LATERAL) LOAD TEST PARALLEL TO RAFTER

Six samples were tested for shear strength parallel to rafter on January 10th, 2015 using a United Universal testing machine. Samples were rigidly attached to the testing machine and a shear load was applied to the hook parallel to the rafter. The samples were loaded at a constant rate of axial deformation of 0.09 in./min. without shock until failure occurred. Based on the above testing, the average ultimate load, of the QMHLS attached to a 2"x4" Douglas Fir rafter using two 5/16"Ø x 3.5" lag bolts was determined to be 832 lbf. Detailed results are provided in Table III. Test setup and mode of failure are provided in Appendix B, Figure 3.

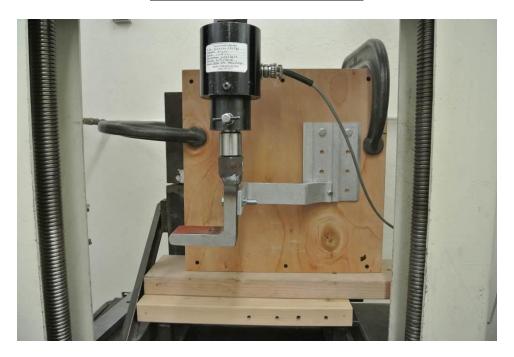
Figure 4a. Test Setup

SHEAR (LATERAL) LOAD TEST PERPENDICULAR TO RAFTER

Six samples were tested for shear strength perpendicular to rafter on January 13th, 2015 using a United Universal testing machine. Samples were rigidly attached to the testing machine and a shear load was applied to the hook perpendicular to rafter. The samples were loaded at a constant rate of axial deformation of 0.09in./min. without shock until failure occurred. Based on the above testing, the average ultimate shear load, of the QMHLS attached to a 2"x4" Douglas Fir rafter using two 5/16"Ø x 3.5" lag bolts was determined to be 1584 lbf. Detailed results are provided in Table IV. Test setup and mode of failure are provided in Appendix B, Figure 4.
